DOT/FAA/AR-99/6

Fiber-Reinforced Structures for Turbine Engine Rotor Fragment Containment

September 1999

Final Report

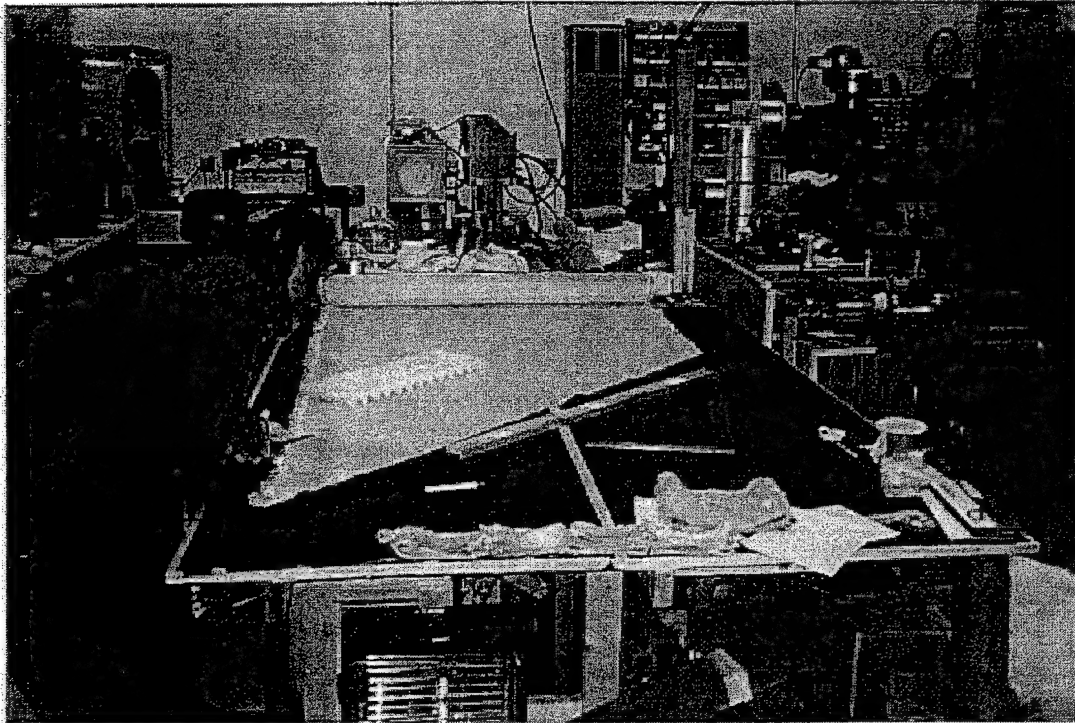
FIGURE 30. CUTTING THE PBO FABRIC AT A 45° ANGLE

The PBO fabric used for this test ring was a 16 x 16 plain weave with 3000 denier unsized but twisted yarns. Since the tows were available only in the unsized condition, they were twisted so they could be easily woven. Fabric weight was 0.439 kg/m². This ring had 43 plies with the same layup and architecture as the Kevlar thermal test ring previously described. As with the previous ring, no rods or facesheets were added. The mass of this ring was 5.73 kg and it had the following dimensions: ID 38.10 cm, OD 43.78 cm, and axial length 24.13 cm. Figures 30 through 33 show the cutting and sewing steps required to build the ring, and the finished ring is shown in figures 34 and 35.

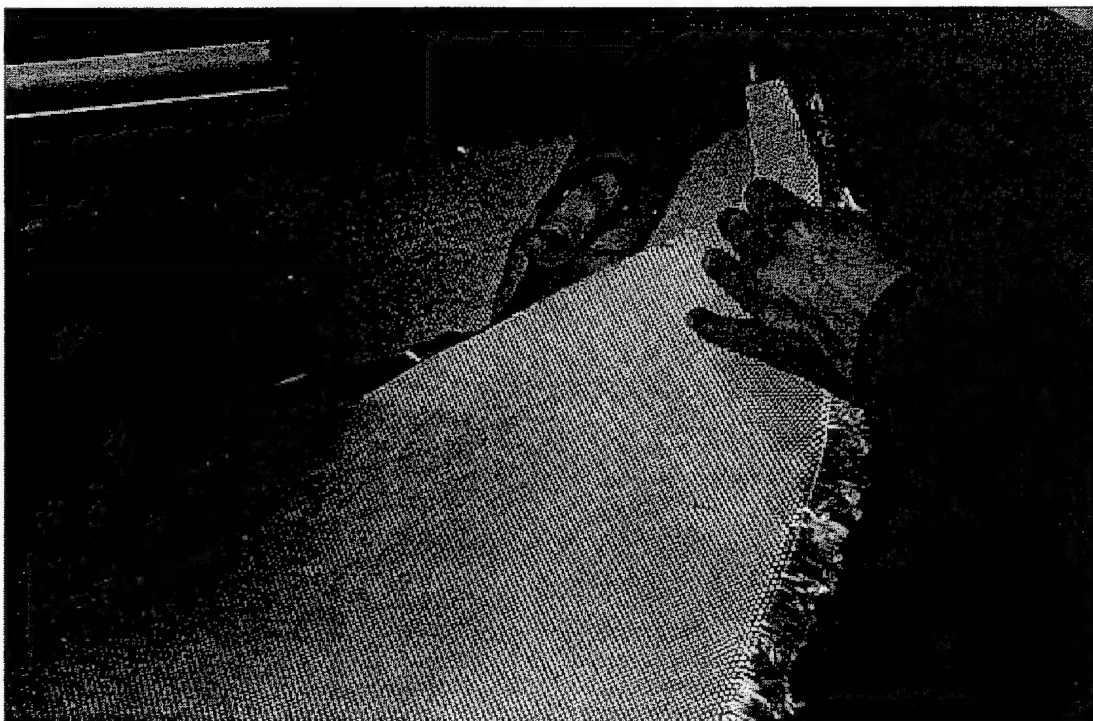
FIGURE 31. CLOSE-UP OF MANUAL CUTTING OF PBO FABRIC

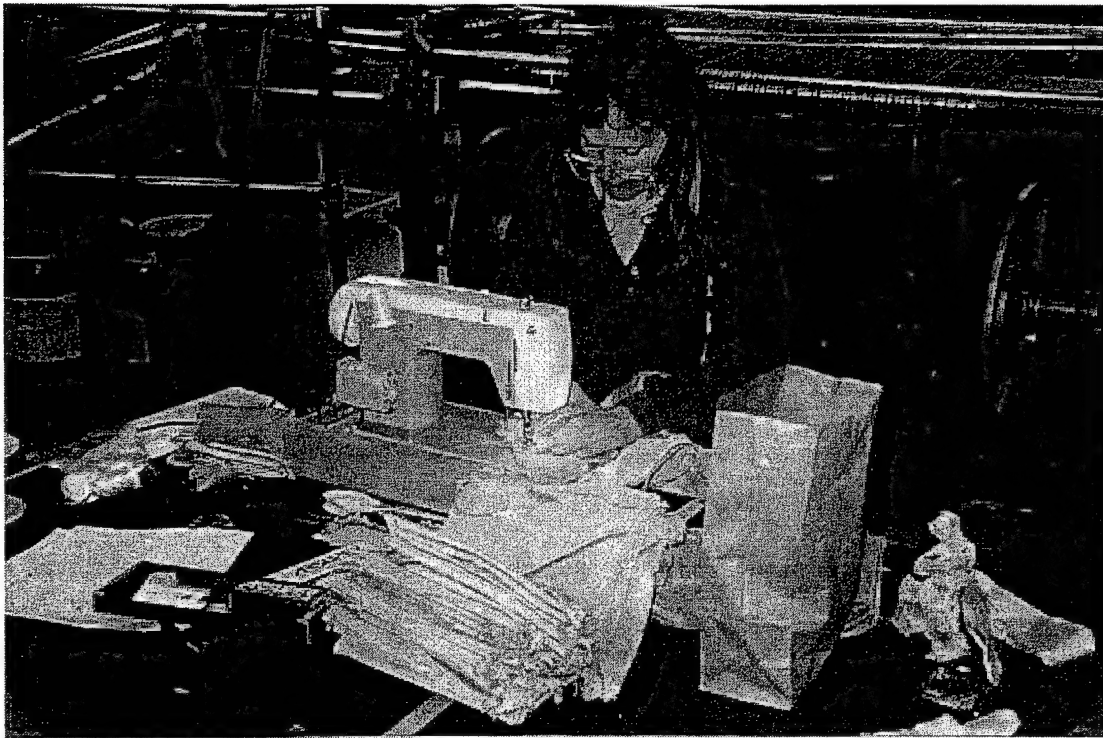
FIGURE 32. SEWING DRAW STRING STRIPS TO EDGE OF FABRIC

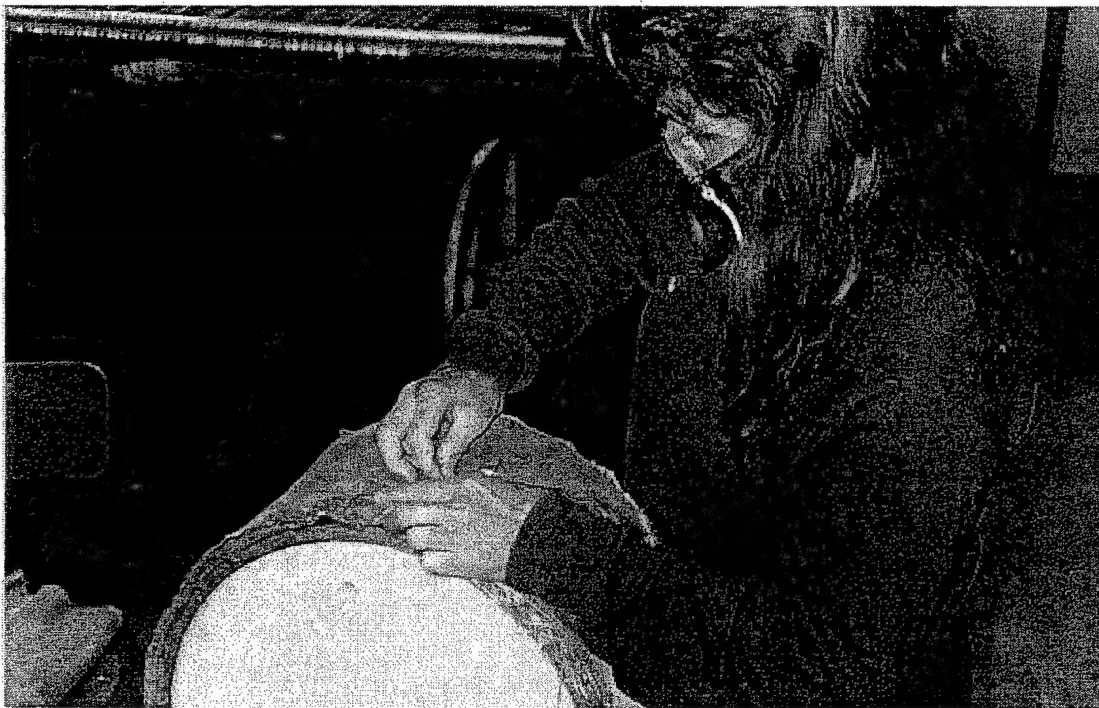
FIGURE 33. LAYUP OF PBO CONTAINMENT RING

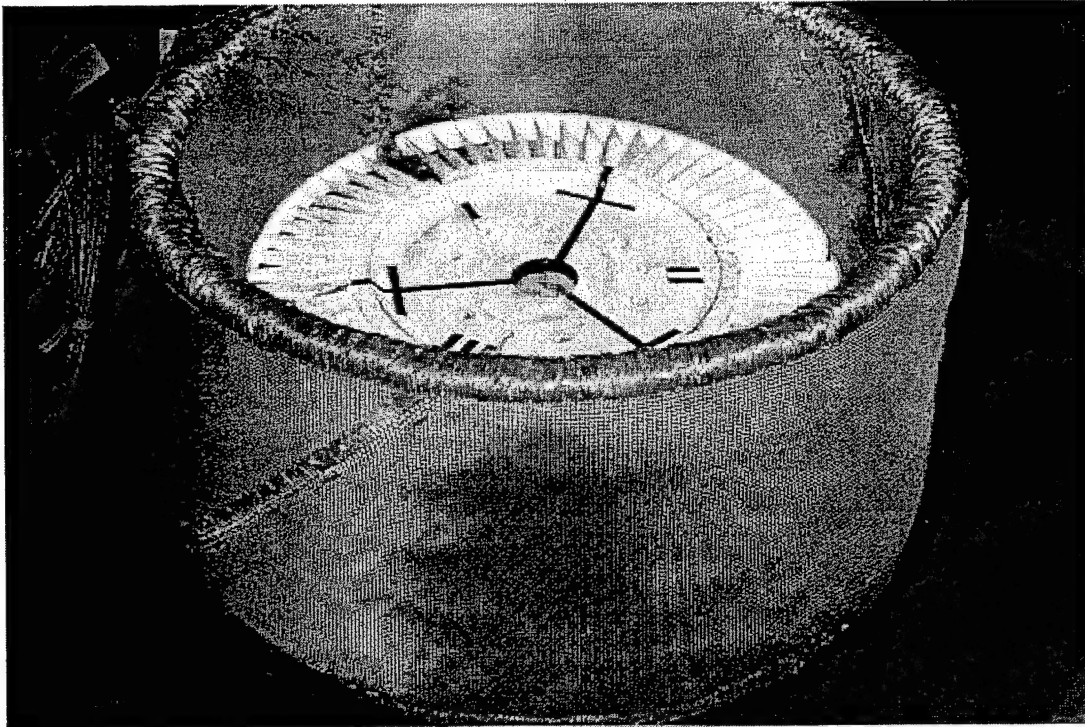
FIGURE 34. FINISHED PBO CONTAINMENT RING

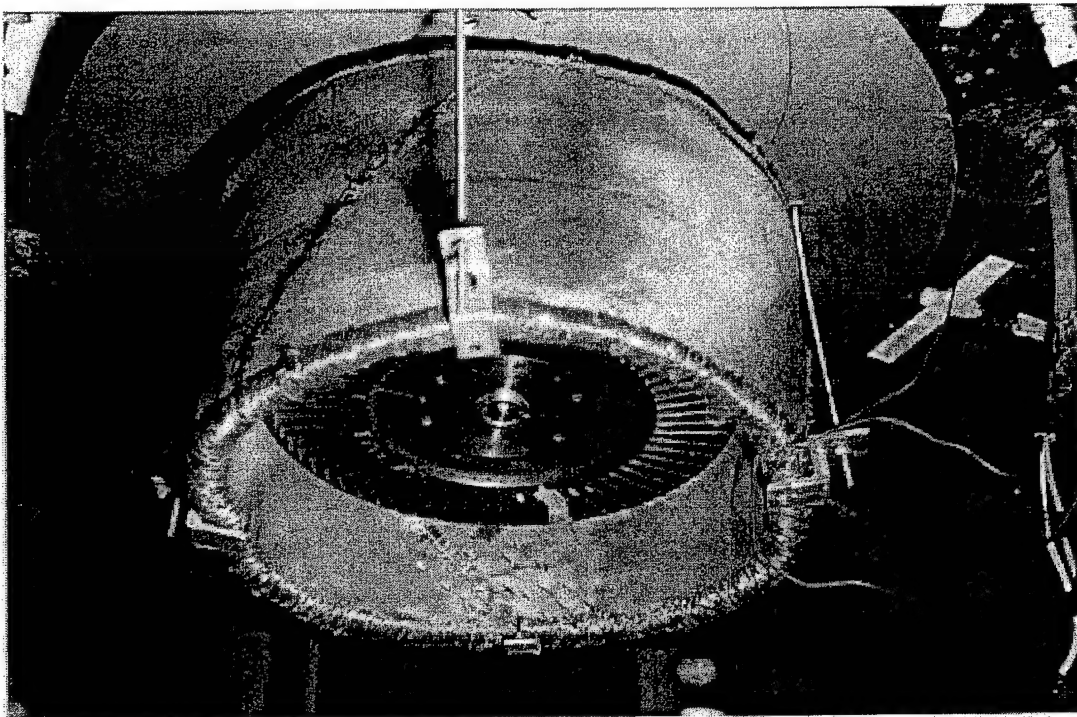
FIGURE 35. PBO CONTAINMENT RING SUSPENDED FROM COVER
OF SPIN CHAMBER

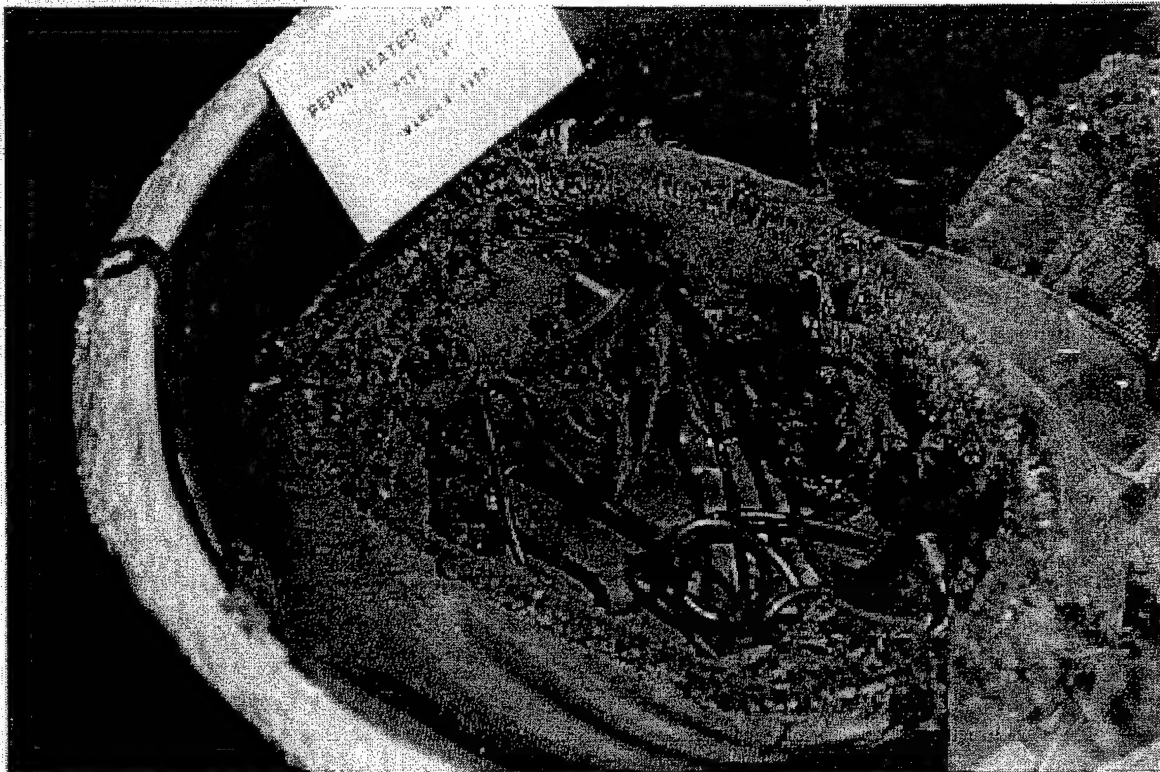
FIGURE 36. POSTTEST PHOTO SHOWING PBO RING, FRAGMENTS, AND HEATING ELEMENTS

The rotor failed at 20,200 rpm and the ring contained all the fragments. The deepest penetration by one of the disk segments was 41 plies leaving only 2 plies undamaged. Thus, this design at the 200°C temperature was close to the threshold of containment. Figures 36 and 37 show the posttest condition of the PBO thermal test ring.

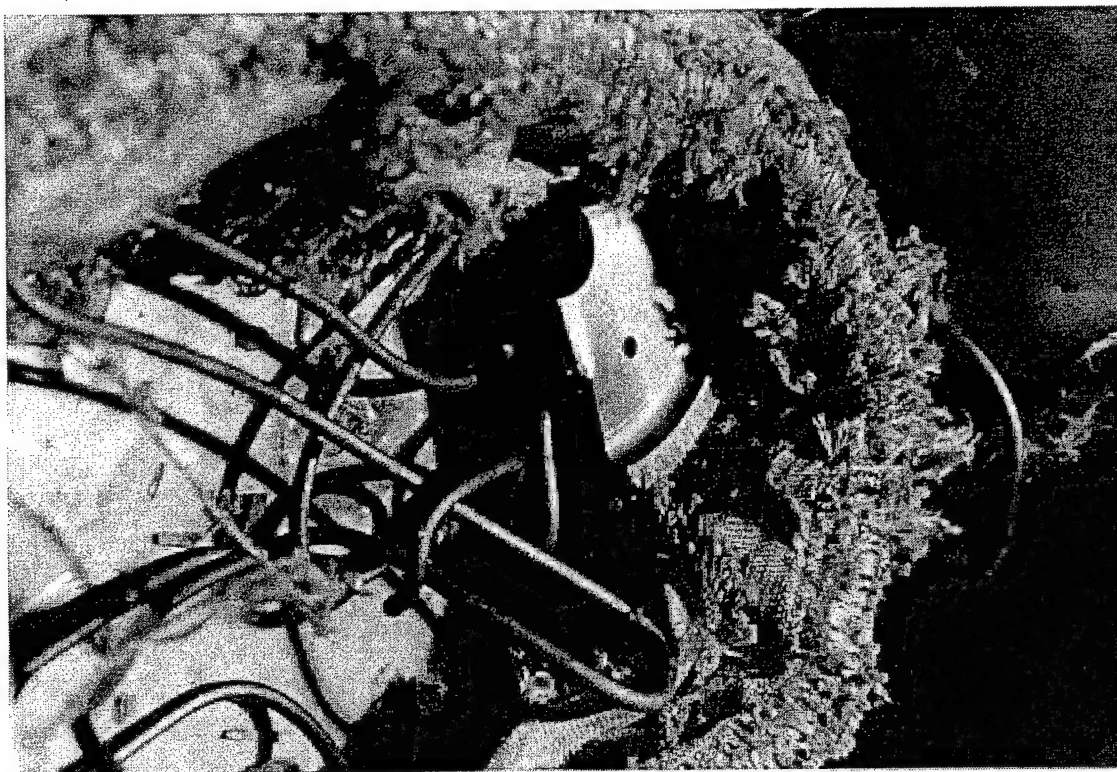
FIGURE 37. CLOSE-UP OF PBO RING AFTER TESTING

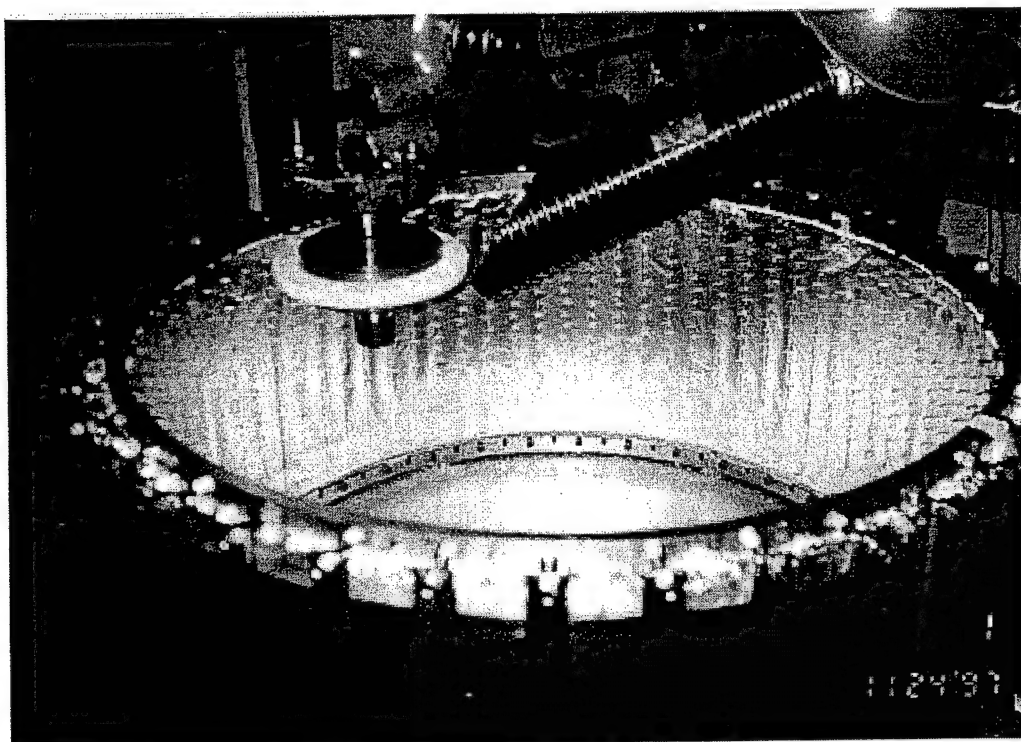
FIGURE 39. GRINDING ROD ENDS ON ID SURFACE OF FULL-SCALE TEST CONTAINMENT RING

vertical slots in the tool. This was done with a pneumatic insertion device designed and built for this task. After the rods were inserted, the protruding rods at the OD were ground so that their ends would form a cylindrical shape standing about 3.8 mm away from the foil covered fabric. Then a facesheet was wrapped around the outside surface, held with clamps, and welded to the rod ends with circumferential weld beads. The speed of welding with the laser was 700 cm/min. After the OD facesheet was attached the tooling was rearranged to hold the ring from the outside surface. The ends of the rods at the ID were then ground and the ID facesheet welded to the ends of the rods. The ID grinding operation is shown in figure 39, and the welding set up is shown in figure 40. The finished ring is given in figure 41. The final ring mass was 11.4 kg with the Kevlar comprising 9.1 kg of that total. The dimensions of the full-scale test ring were as follows: ID 63.5 cm, OD 70.6 cm, and axial length 24.8 cm.

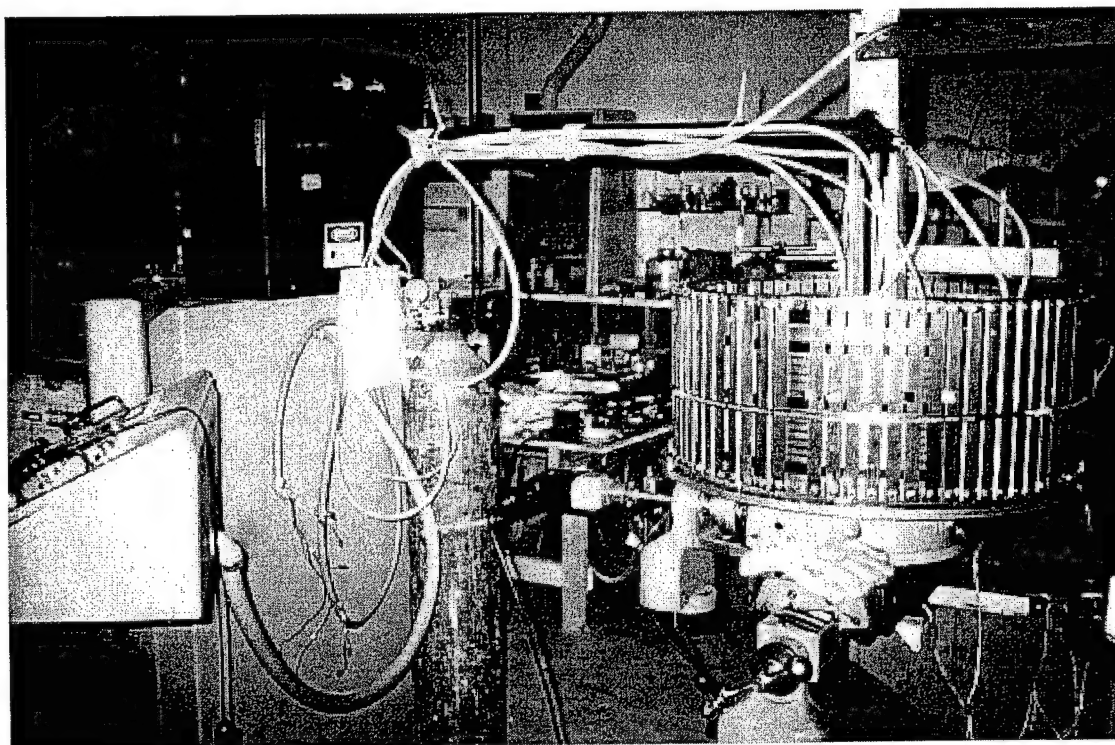
FIGURE 40. LASER SETUP FOR WELDING ID SURFACE OF FULL-SCALE TEST CONTAINMENT RING

The full-scale test ring was a large-diameter ring designed to fit around the T-53 engine's outer case. This ring was designed to demonstrate the ability of the hybrid panel concept to contain the rotor disk failure on a full-scale, running T-53 engine. The ring design consisted of 40 plies of Kevlar 29 style 745 with a [0/90] architecture; that is, the fiber reinforcement of the fabric coincided with the axial and circumferential directions of the containment ring. This architecture was selected to reduce the radial deformation of the containment ring since the engine was mounted to a UH1 airframe and the tail rotor shaft passes just under the engine. The 40-ply Kevlar fabric core was surrounded with a 6-4 titanium structure of through-the-thickness rods and overlaying facesheets. The rods were inserted in circumferential rows. The rods within each row were 25.4 mm apart while the rows themselves were 13 mm apart. The circumferential rows of rods alternated between + and - 45 degree rod penetration angles. The rod diameter was 1.57 mm and the nominal facesheet thickness was 0.38 mm. The rods were welded to the facesheets with a 1500-watt CO₂ laser.

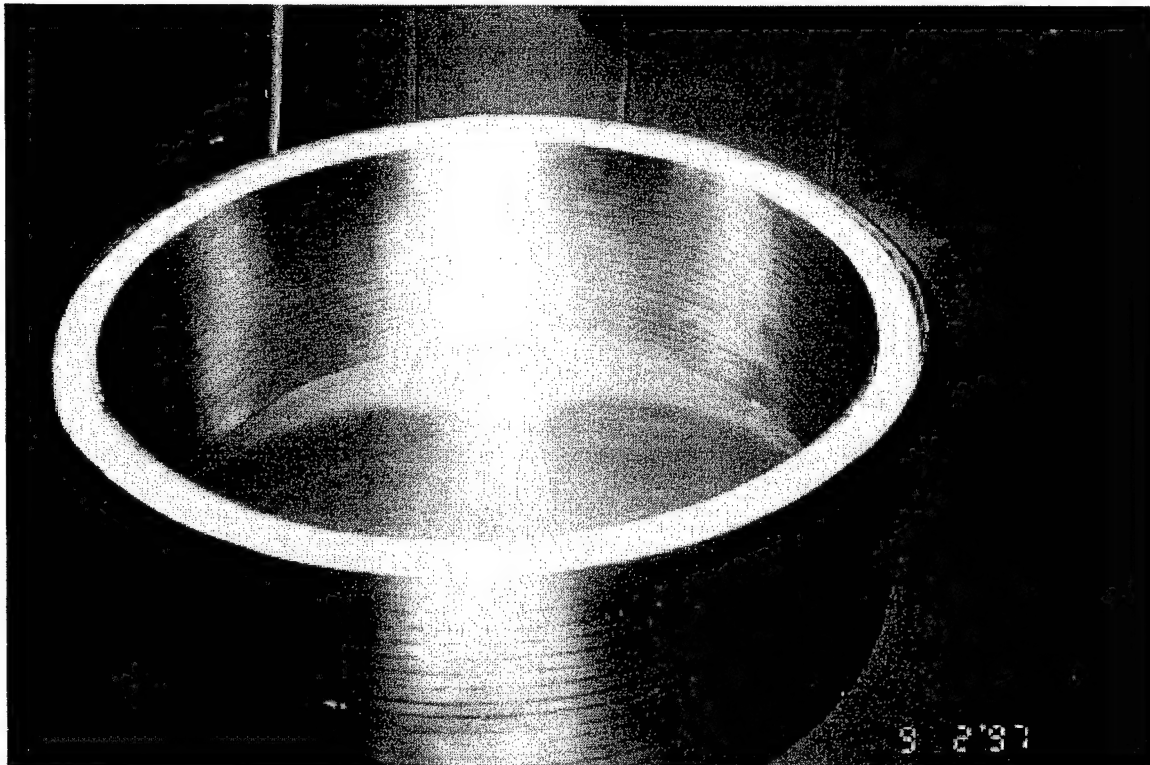
FIGURE 41. COMPLETED FULL-SCALE TEST CONTAINMENT RING

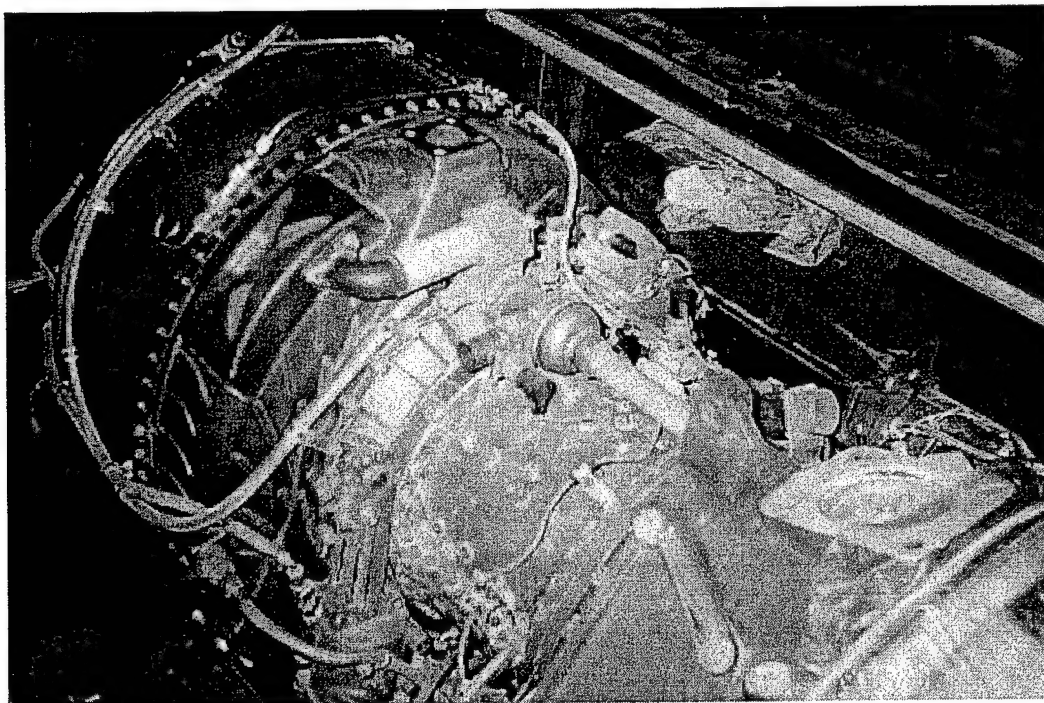
FIGURE 42. T-53 ENGINE USED IN FULL-SCALE TEST

The engine for the full-scale test was donated to this program by the U. S. Army Aviation and Missile Command in Huntsville, Alabama, (at the time the engine was donated the organization was AVSCOM in St. Louis). The T-53 engine second stage power turbine rotors which are used in the spin chamber tests have the hub area machined flat to attach to the air drive turbine shaft. The actual power turbine stage in the engine has an attached hub and shaft. It was therefore necessary to modify the disk so that the rotor would fail at the required rpm in the running engine. This modification and verification test work was done in Rotor Spin Facility (RSF) of the Naval Air Warfare Center in Trenton, New Jersey, prior to installing an actual turbine in the engine. The removal of the second power turbine from the T53 engine and the installation of the modified one were done by NAWCAD-TRN personnel at the New Jersey National Guard facility in Trenton, New Jersey. The engine was then shipped to the Naval Air Warfare Center, Weapons Division in China Lake, California, where it was mounted to a UH1 Huey helicopter for the test. Figures 42 and 43 show the engine and figure 44 shows the engine mounted on the helicopter with the containment ring attached. The midplane of the containment ring was aligned with the disk plane of the second stage power turbine.

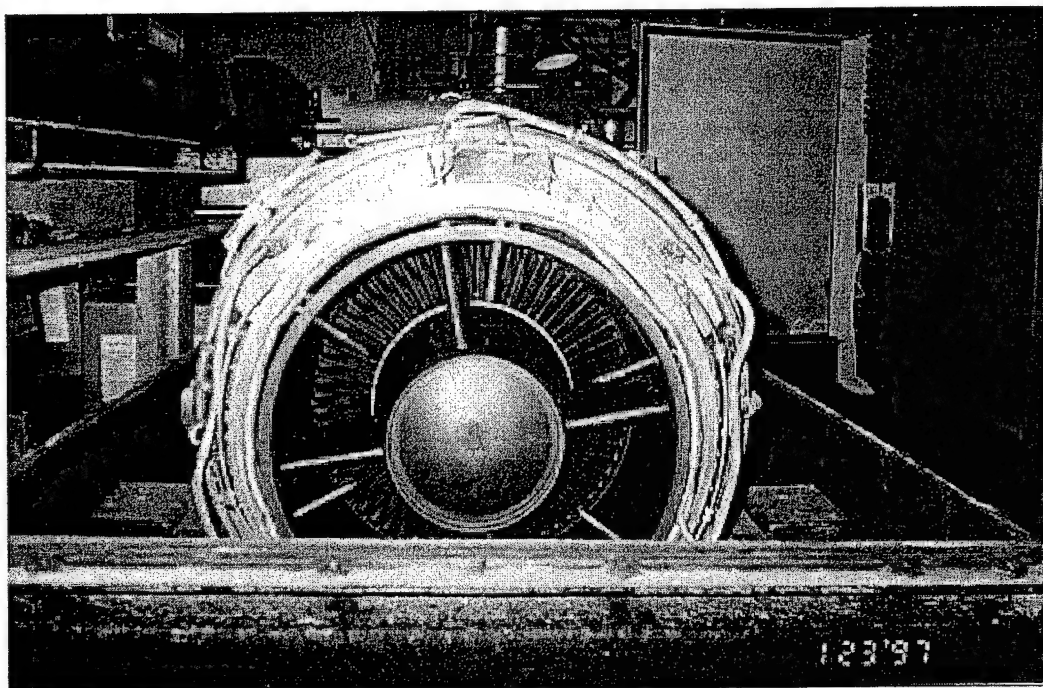
FIGURE 43. VIEW FROM THE AFT END OF THE T-53 ENGINE SHOWING THE SECOND STAGE POWER TURBINE

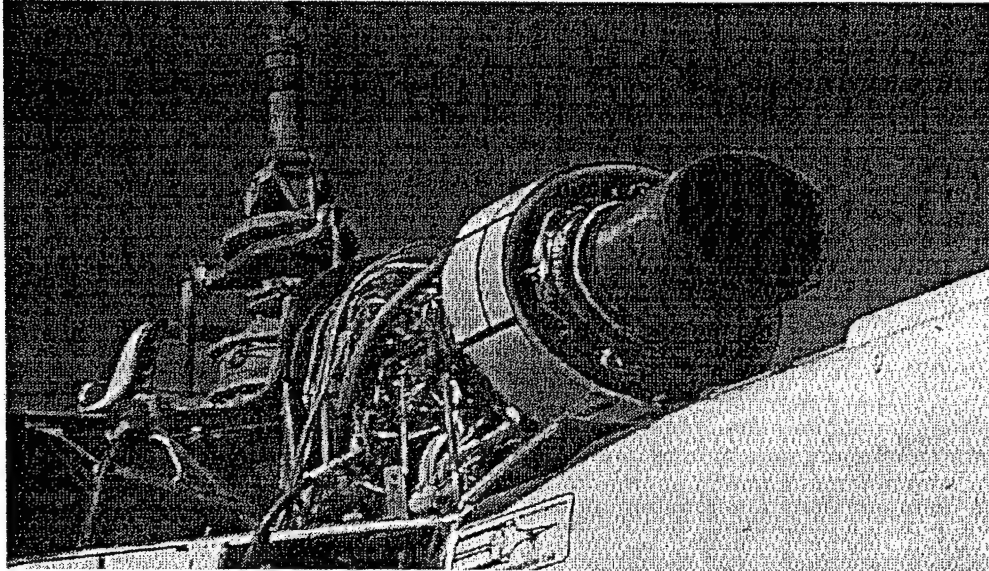
FIGURE 44. FULL-SCALE TEST SETUP SHOWING T-53 ENGINE AND CONTAINMENT RING BEFORE TEST

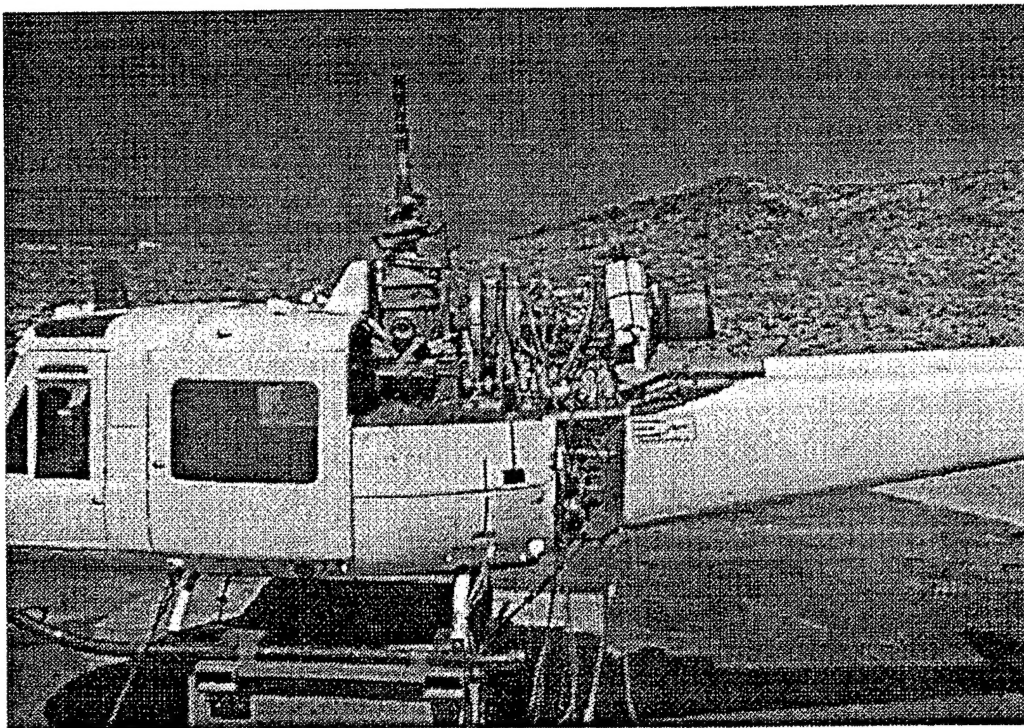
FIGURE 45. POSTTEST PHOTO SHOWING HELICOPTER AIRFRAME,
ENGINE, AND CONTAINMENT RING

The full-scale engine test was performed at China Lake on September 23, 1997. The containment ring contained all three rotor disk fragments. Only a few (3-5) plies at the ID of the containment ring were penetrated indicating that the ring was probably overdesigned for the containment task; however, the radial deformation was minimized for this type of containment material and design. There was a fire of short duration and a few of the ID plies of the fabric were burned. The OD facesheet failed in tension and split along the welds while the ID facesheet failed more locally at the impact sites of the three disk fragments. The ID facesheet seemed to cover the impacting fragment thereby protecting the fabric from the sharp edges of the disk segments. The ID rod-to-facesheet welds pulled out but the rods remained in the dry laminate for the most part. Rod pull out and bending can absorb additional energy and this could be a factor in future hybrid panel designs. Both real-time and high-speed video were taken from four camera positions around the helicopter. Figures 45 through 48 show posttest photos from different angles around the helicopter.

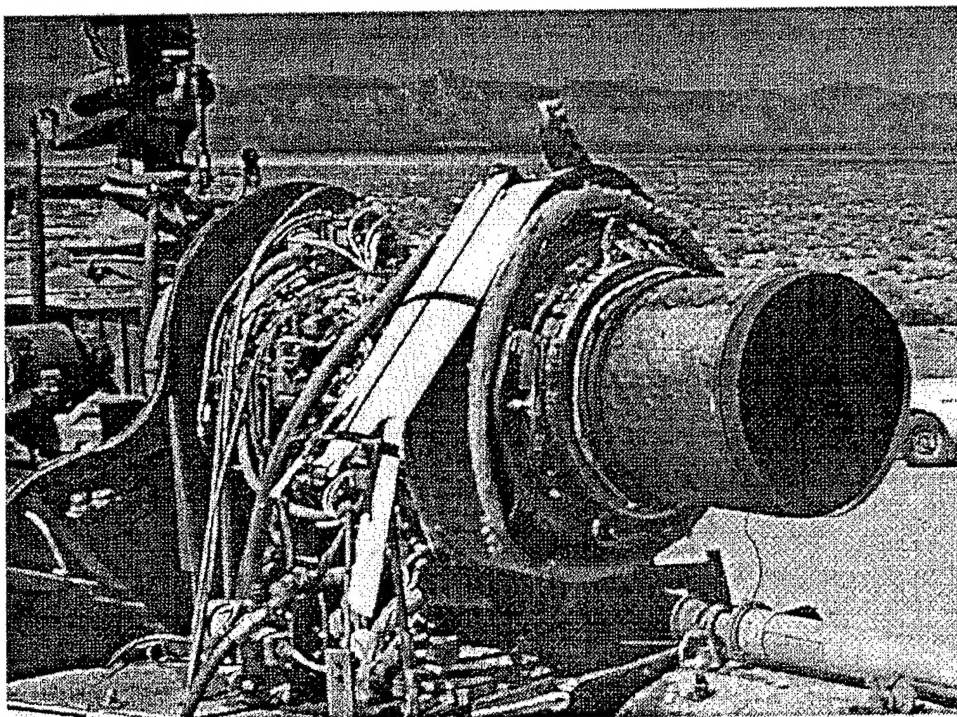
FIGURE 46. CLOSE-UP OF THE LEFT SIDE OF THE ENGINE SHOWS OUTER
FACESHEET PEELED BACK

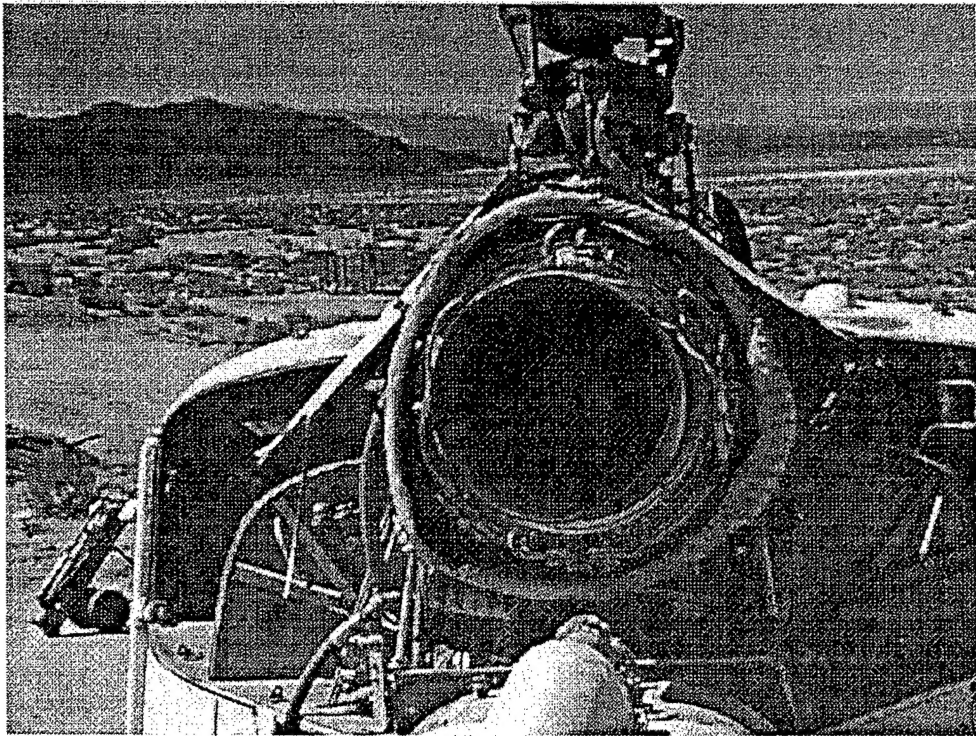
FIGURE 47. VIEW FROM THE TAILPIPE; BULGES IN THE RING INDICATE DISK
FRAGMENT IMPACT

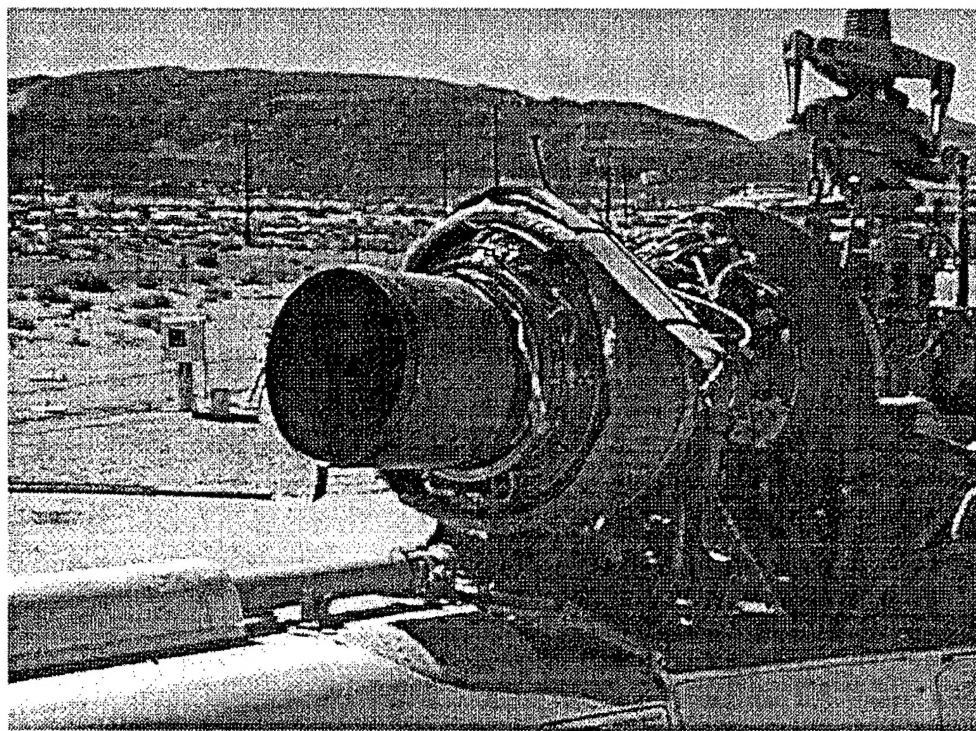
FIGURE 48. POSTTEST VIEW FROM THE RIGHT SIDE OF THE ENGINE
